# Condition Assessment :: August 2016

Shakesides - 1431 Comox Avenue - circa 1950

Plan 3387 District Lot 87 Lot 2 - Comox District, British Columbia

# Condition Assessment for Shakesides

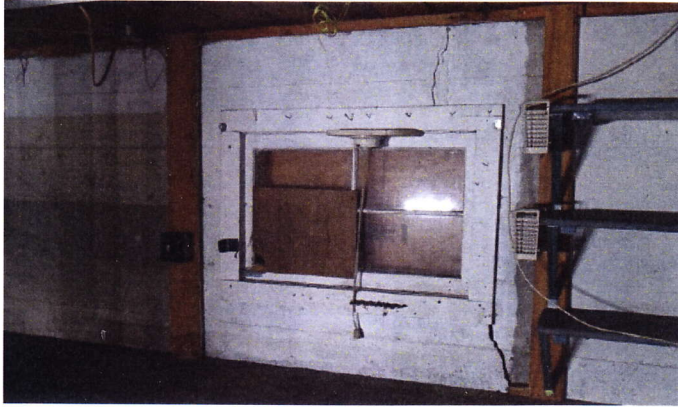
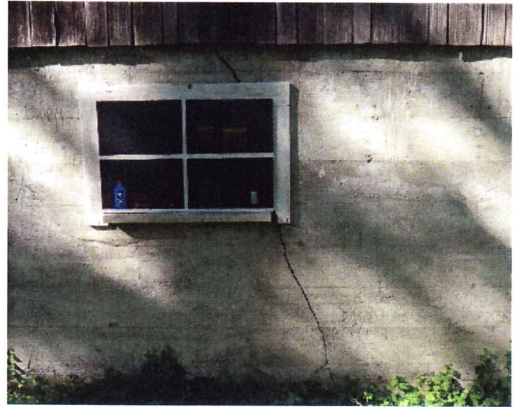
The concrete appears solid with a crack on the north wall running diagonally through the small window east of the entrance. The crack can also be seen outside in the same location. There is a crack on the south wall running diagonally through a small window and can be seen outside in the same location. The rest of the concrete appears to be in good condition.

The concrete foundation appears to be in good condition with one crack on the north side of the house and a crack through the foundation on the south side under the porch. Like the north side crack, this one is associated with a window opening. Above the basement, the house is clad in hand split cedar shingles above the basement foundation. On the north, west and south walls they appear to be in reasonable condition given their age and exposure to the elements. Some splitting and warping can be seen. On the east wall, the weather side, the shingles are thin, cracked and in need of replacement after years of exposure to the elements.

The cracks in the foundation. Inside south wall, exterior north wall

Given the location of the house, its exposure to the elements, the materials used in the construction and its age, the house is in reasonably good condition overall. Much of the visible damage is due to the weathering of the cladding materials. The foundation cracks do need to be assessed to determine if the foundation is still moving or if this is an old but stable situation.

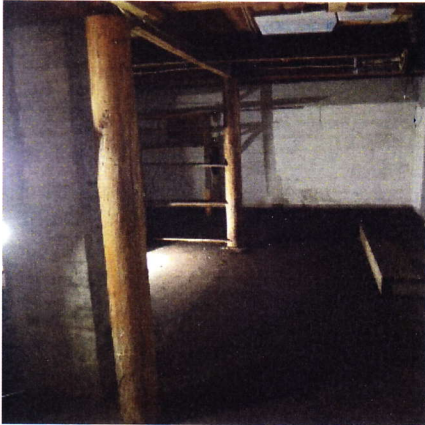
**Basement:** The basement is dry, though there are indications that water has entered the house. The log posts are solid and dry with no evident moisture damage. Wooden platforms remain in the basement used by the owner and tenants to raise appliances and work surfaces above any potential flooding.

Basement with log posts and platform for washer and dryer.

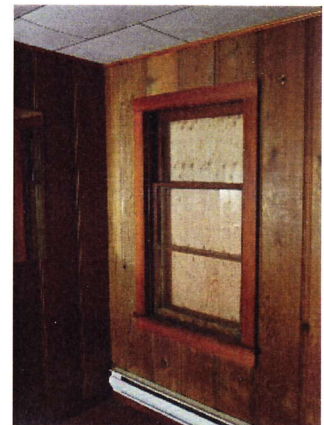
Rooms retained their trim, mouldings, flooring and panelling, all of which was in good condition considering the age of the building and its general lack of maintenance. The windows are original and those that were accessible appeared to be in good condition. Putty was strong and unbroken, window panes were secure. The wood frames showed no signs of rot, though some staining on the inside woodwork was evident, a result of condensation on the glass.

Window and panelling

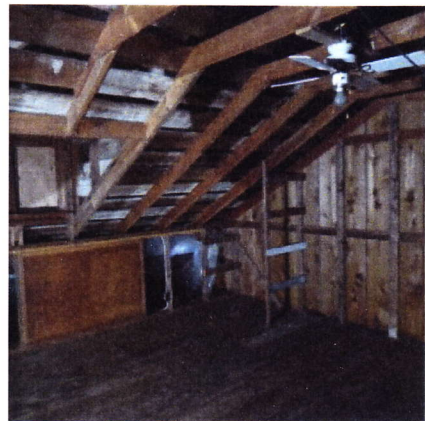
**Second Floor:** The upper floor of the house is an unfinished work space with exposed studs and rafters. There is no insulation or wall coverings, though the east wall had a floor to ceiling plastic sheet attached to the studs. The roof rafters, walls and floor were dry and there was no sign of water stains on the woodwork. The dormer windows retained original panes though the casements showed signs of prolonged exposure to the weather.

Upper floor

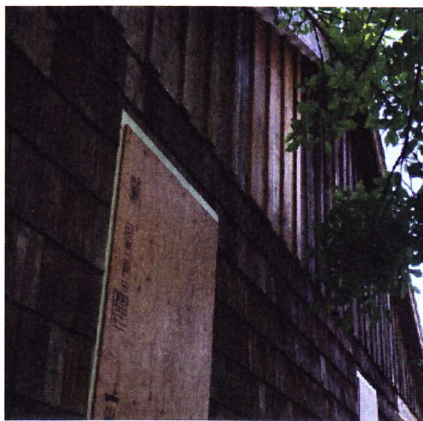
The gable ends are clad in board and batten. On the west gable repair work can be clearly seen, but the work has been done to match the existing cladding. Once weathered it will be indistinguishable from the original. On the east gable the board and batten cladding appears in good shape with some minor decay visible at the end of the boards above the shingles.

West wall with shingles, board and batten showing the gable repair

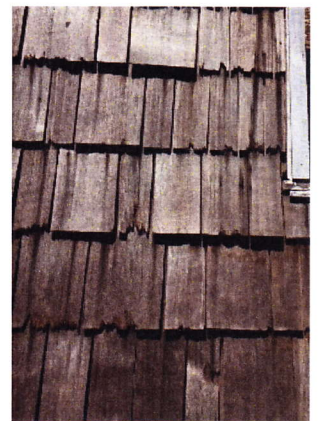
Shingles on the east wall showing weather damage

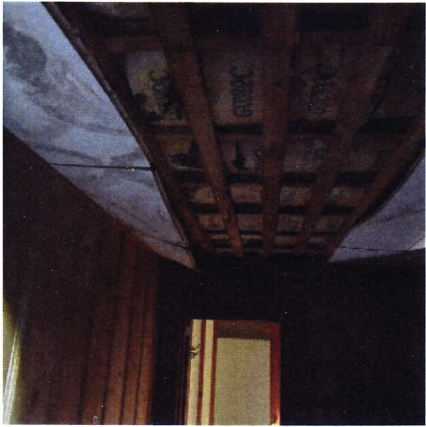
Water damage was seen in the ceiling of one room in the north side of the house where the fibrous ceiling panels showed signs of staining. Some ceiling panels had been removed but the Gyproc wool batts appeared in reasonable condition.

Water stains on the ceiling tiles and exposed insulation batts

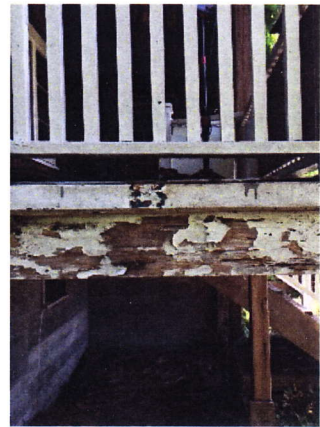
The porch is in reasonable condition given its exposure and lack of maintenance. There is rot visible on western and south facing facias. Underneath the porch deck the beams and flooring appear to be in good shape.

Some rot in the front porch
